**Flood Control Project Maintenance
Levee Inspections**

Maintenance Issue Types Only, Levee Inspection Report By Mile - Spring 2018

Reclamation District No. 0341 Sherman Island

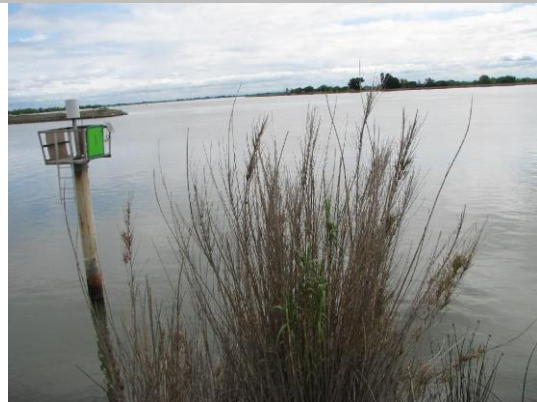
Photo 1 of 3 : UCIP_SP_2018_52252_37640.jpg

Comment Code					
Inspector Comment					
<p>FS_ID:52252 DS_ID:24215 EP_NO: N/A Repair Type: Non-Urgent Crossing Status: Found UCIP Comments: 05/05/2009 Dense vegetation limits the inspector's visibility to identify signs of pipe failure (leaks) along the slopes. Recommend removing vegetation along pipe alignment to conduct proper inspection of structure and appurtenances. (DWR UCIP - O. Magana) FIELD_STRUCT_DESC: 30-inch steel drainage pipe through the levee, 11.1 feet below the crown. Corrugated metal cutoff wall around pipe at the center of the levee. Siphon breaker is located on both waterside (WS) and landside (LS). Pump is located on the LS approximately 300 feet from LS toe. Pipe is exposed on both levee slopes. Rock revetment present along WS slope. Marine Station number 1 located on WS with an attached small solar panel on top. [Additional Reference(s): DWR Levee Log, 1992. USACE Sacramento O&M Manual Unit No. 101, February 1962, (HLM 0.0). LMA encroachment station (STA) reference based on Map of Evacuation Route, Reclamation District 341 Sherman Island by Wagner Bonsignore Consulting Civil Engineers, A Corporation dated July 2012, STA 175+00]. FS Date: 5/5/2009</p>

Marine station posts in river identified as Station 1 near crossing.

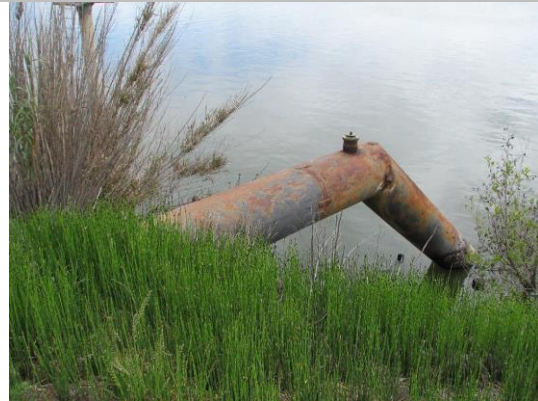
Photo 2 of 3 : UCIP_SP_2018_52252_37644.jpg

FS_ID:52252
DS_ID:24215
EP_NO: N/A
Repair Type: Non-Urgent
Crossing Status: Found
UCIP Comments: 05/05/2009 Dense vegetation limits the inspector's visibility to identify signs of pipe failure (leaks) along the slopes. Recommend removing vegetation along pipe alignment to conduct proper inspection of structure and appurtenances. (DWR UCIP - O. Magana)
FIELD_STRUCT_DESC: 30-inch steel drainage pipe through the levee, 11.1 feet below the crown. Corrugated metal cutoff wall around pipe at the center of the levee. Siphon breaker is located on both waterside (WS) and landside (LS). Pump is located on the LS approximately 300 feet from LS toe. Pipe is exposed on both levee slopes. Rock revetment present along WS slope. Marine Station number 1 located on WS with an attached small solar panel on top. [Additional Reference(s): DWR Levee Log, 1992. USACE Sacramento O&M Manual Unit No. 101, February 1962, (HLM 0.0). LMA encroachment station (STA) reference based on Map of Evacuation Route, Reclamation District 341 Sherman Island by Wagner Bonsignore Consulting Civil Engineers, A Corporation dated July 2012, STA 175+00].

View of pipe and siphon breaker located on WS--dense vegetation on slope.

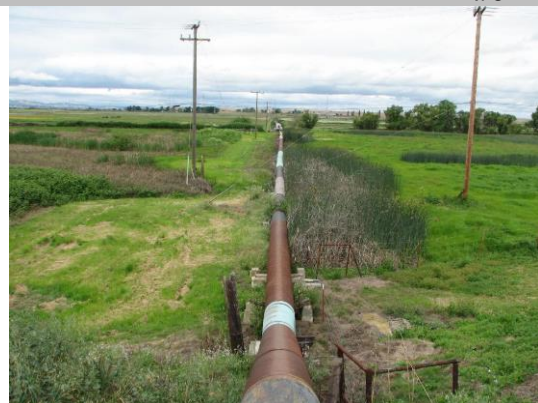
Photo 3 of 3 : UCIP_SP_2018_52252_37642.jpg

Overview of LS slope above ground once it exits levee. Pump is located approximately 300 feet from levee toe.

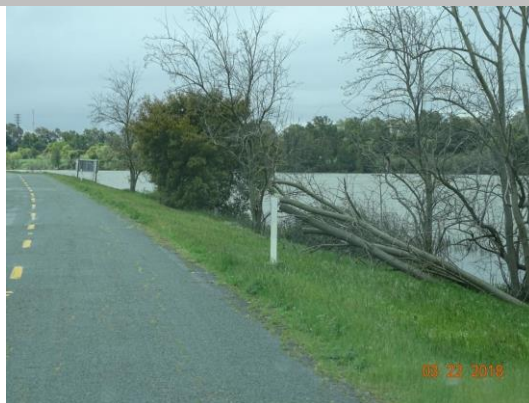
Photo 1 of 1 : SP_2018_RD0341_167_21_20180322_00052.jpg

LM Start	2.19	Rating **	M	Issue No.	21
LM End	2.19	Issue Type +	Ma	Location *	WS
Category	Earthen Levee			GPS Latitude/Longitude	
				Start	End
Item	Encroachments			38.113144 °	38.113144 °
				-121.687601 °	-121.687601 °
DWR ID	DWR_RD0341_01_s_2018_21				
Comment Code					
TR : Tree or limb					
Inspector Comment					
Remove fallen tree on waterside slope.

Fallen tree on waterside slope should be removed.

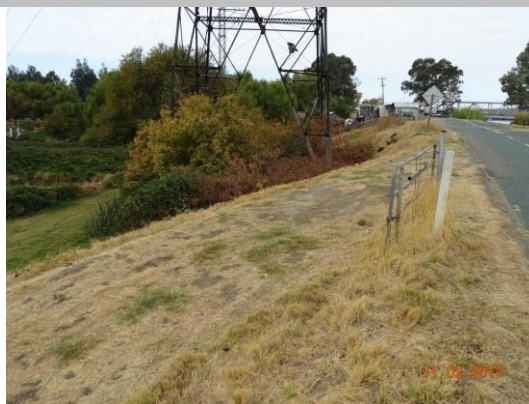
Photo 1 of 1 : SP_2018_RD0341_167_22_20180305_00002.jpg

LM Start	3.21	Rating **	M	Issue No.	22
LM End	3.21	Issue Type +	Ma	Location *	LS
Category	Earthen Levee			GPS Latitude/Longitude	
				Start	End
Item	Vegetation			38.104677 °	38.104677 °
				-121.700030 °	-121.700030 °
DWR ID	DWR_RD0341_01_f_2017_22				
Comment Code					
V2 : Remove the wild growth other than native grasses from the levee slopes.					
Inspector Comment

Remove or thin wild vegetation at base of electrical transmission tower to allow visibility and access to slope and toe.

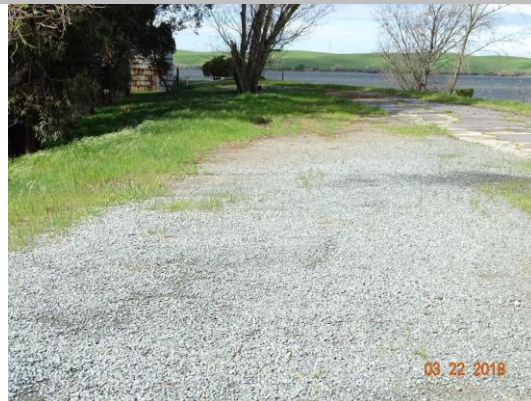
Photo 1 of 1 : SP_2018_RD0341_168_36_20180322_00085.jpg

LM Start	3.36	Rating **	A/W	Issue No.	36
LM End	3.94	Issue Type +	Ma	Location *	LS
Category	Earthen Levee			GPS Latitude/Longitude	
				Start	End
Item	Vegetation			38.105315 °	38.098158 °
				-121.702537 °	-121.706320 °
DWR ID	DWR_RD0341_02_s_2017_36				
Comment Code					
V2 : Remove the wild growth other than native grasses from the levee slopes.					
Inspector Comment					
Weeds have been reduced to an acceptable level in this area.

Acceptable landside vegetation.

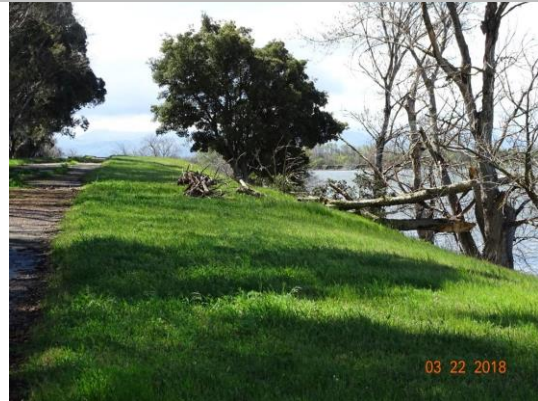
Photo 1 of 1 : SP_2018_RD0341_168_44_20180322_00086.jpg

LM Start	3.48	Rating **	M	Issue No.	44
LM End	3.48	Issue Type +	Ma	Location *	WS
Category	Earthen Levee			GPS Latitude/Longitude	
				Start	End
Item	Encroachments			38.104454 °	38.104454 °
				-121.704275 °	-121.704275 °
DWR ID	DWR_RD0341_02_s_2018_44				
Comment Code					
TR : Tree or limb					
Inspector Comment					
Remove tree limbs from waterside shoulder.

Tree limbs on waterside shoulder should be removed.

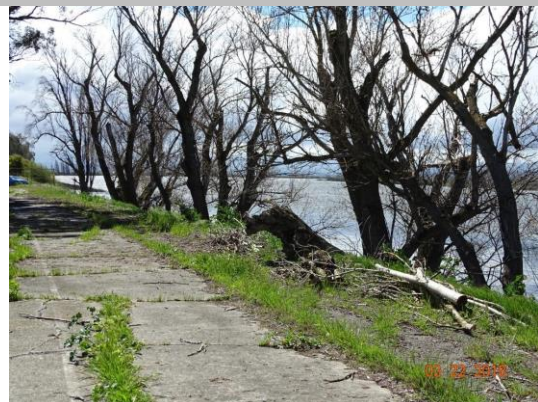
Photo 1 of 1 : SP_2018_RD0341_168_46_20180322_00087.jpg

LM Start	3.88	Rating **	M	Issue No.	46
LM End	3.88	Issue Type +	Ma	Location *	WS
Category	Earthen Levee			GPS Latitude/Longitude	
				Start	End
Item	Encroachments			38.099054 °	38.099054 °
				-121.706368 °	-121.706368 °
DWR ID	DWR_RD0341_02_s_2018_46				
Comment Code					
TR : Tree or limb					
Inspector Comment					
Remove tree and limbs from waterside shoulder.

Tree trunk and limbs should be removed from waterside shoulder.

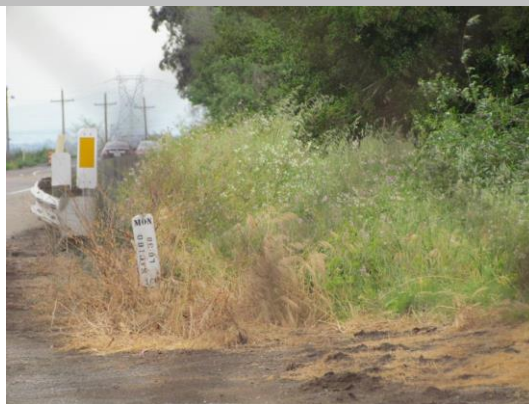
Photo 1 of 1 : SP_2018_RD0341_168_41_20180305_00009.jpg

LM Start	3.94	Rating **	U	Issue No.	41
LM End	6.14	Issue Type +	Ma	Location *	WS
Category	Earthen Levee			GPS Latitude/Longitude	
				Start	End
Item	Vegetation			38.098158 °	38.080223 °
				-121.706320 °	-121.730312 °
DWR ID	DWR_RD0341_02_s_2017_41				
Comment Code					
V2 : Remove the wild growth other than native grasses from the levee slopes.					
Inspector Comment					
Remove the unwanted vegetation from the waterside shoulder and slope.

Looking downstream from levee mile 3.94 at tall unwanted weeds and other vegetation on the waterside shoulder and slope.

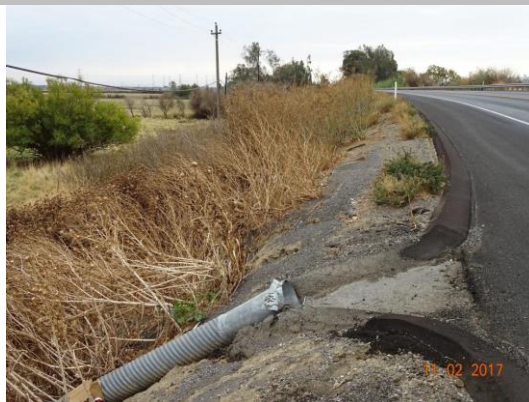
Photo 1 of 1 : SP_2018_RD0341_168_43_20180305_00013.jpg

LM Start	3.97	Rating **	M	Issue No.	43
LM End	6.03	Issue Type +	Ma	Location *	LS
Category	Earthen Levee			GPS Latitude/Longitude	
				Start	End
Item	Vegetation			38.097782 °	38.080143 °
				-121.706262 °	-121.728330 °
DWR ID	DWR_RD0341_02_f_2017_43				
Comment Code					
V2 : Remove the wild growth other than native grasses from the levee slopes.					
Inspector Comment					
Remove the unwanted vegetation from the landside shoulder, slope and toe.

Remove the unwanted vegetation from the landside shoulder, slope and toe.

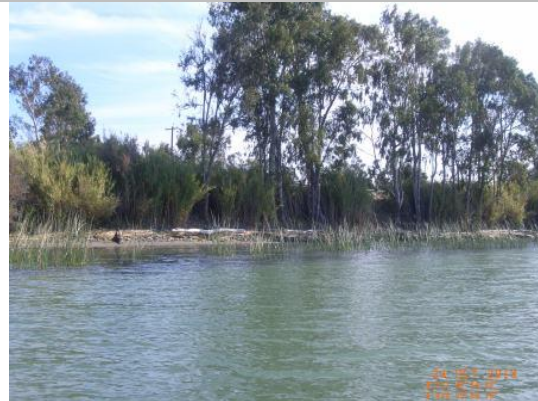
Photo 1 of 1 : SP_2018_RD0341_168_7_20180305_00004.jpg

LM Start	4.15	Rating **	M	Issue No.	7
LM End	4.19	Issue Type +	Ma	Location *	WS
Category	Supplemental			GPS Latitude/Longitude	
				Start	End
Item	2015 USACE Erosion Survey, DRAFT			38.095148 °	38.094590 °
				-121.706367 °	-121.706393 °
DWR ID	DWR_RD0341_02_s_2016_7				
Comment Code					
Inspector Comment					
2011 - Large new erosion pocket probably hidden by vegetation in the past. 2015: No observed changes. [2015 Site ID: SAC_8-2_L]

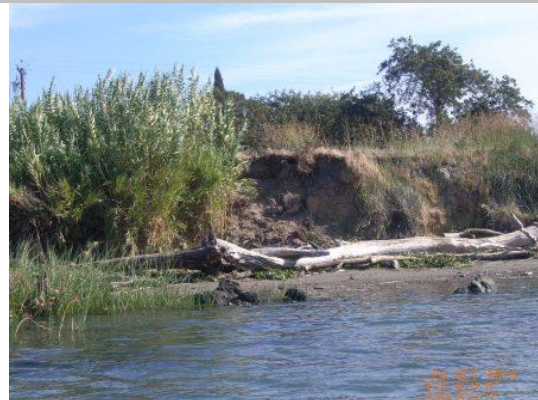
Photo 1 of 1 : SP_2018_RD0341_168_3_20180305_00002.jpg

LM Start	4.47	Rating **	U	Issue No.	3
LM End	4.62	Issue Type +	Ma	Location *	WS
Category	Supplemental			GPS Latitude/Longitude	
				Start	End
Item	2015 USACE Erosion Survey, DRAFT			38.090620 °	38.088572 °
				-121.706684 °	-121.707127 °
DWR ID	DWR_RD0341_02_s_2016_3				
Comment Code					
Inspector Comment					
1999 - New small slump in eroded bank. 2005 - Reach extended because of vertical bank along the roadway upstream. 2011 - More slumping since last year. 2012 - Site upgraded to critical. Very steep slope which may be effecting the highway on top of the levee. 2015: New erosion towards downstream end of site. [2015 Site ID: SAC_8-0_L]

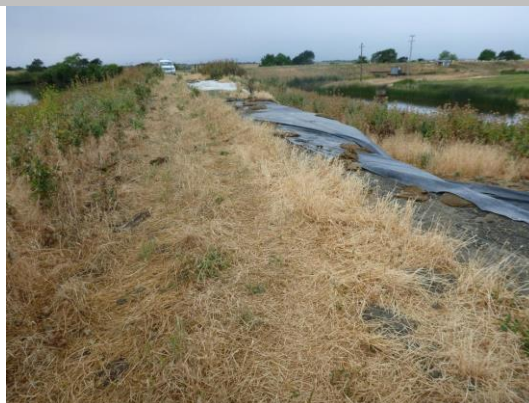
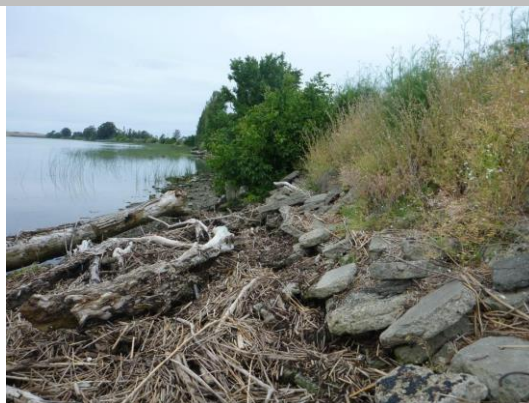
Notes: hwy 160 forms levee crown road, erosion has encroached into paved crown, crown 38' wide. This site is currently under contract for repair under FSRP.

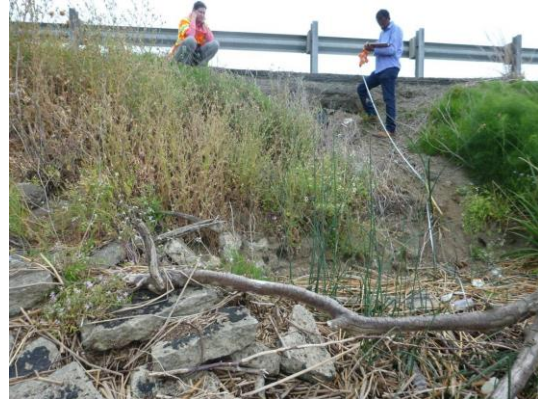
Photo 3 of 3 : SP_2018_RD0341_168_42_20180305_00012.jpg

LM Start	4.75	Rating **	A/W	Issue No.	42 (cont)	
LM End	4.79	Issue Type +	Ma	Location *		
Category	Supplemental			GPS Latitude/Longitude		
				Start	End	
Item	2017 Storm Damage			38.086641 °	38.086119 °	
				-121.707545 °	-121.707912 °	
DWR ID	DWR_RD0341_02_f_2017_42					
Comment Code						
Inspector Comment						
Levee Evaluation Comments						
Description:						
Site ID No:65						
Site Designation:DWR_RD0341_02_s_2012_8						
Repair Type: Erosion						
Rating:Area of Concern						
Field Date:6/8/2017						
Notes: hwy 160 forms levee crown road, erosion has encroached into paved crown, crown 38' wide. This site is currently under contract for repair under FSRP.

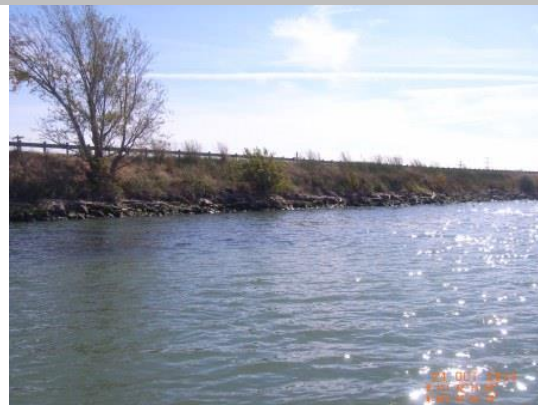
Photo 1 of 1 : SP_2018_RD0341_168_4_20180305_00003.jpg

LM Start	4.76	Rating **	A/W	Issue No.	4
LM End	4.85	Issue Type +	Ma	Location *	WS
Category	Supplemental			GPS Latitude/Longitude	
				Start	End
Item	2015 USACE Erosion Survey, DRAFT			38.086603 °	38.085459 °
				-121.707786 °	-121.708607 °
DWR ID	DWR_RD0341_02_s_2016_4				
Comment Code					
Inspector Comment					
2011 - Large slump section. 2012 - Site extended downstream, upgraded to critical, severe windwave. Slope is very steep and may be effecting the highway on top of the levee. 2015: No observed changes. [2015 Site ID: SAC_7-9_L] 11/02/17: This issue changed from U to A/W due to DWR 2017 Levee Eval Storm Site issue with U rating at same location.

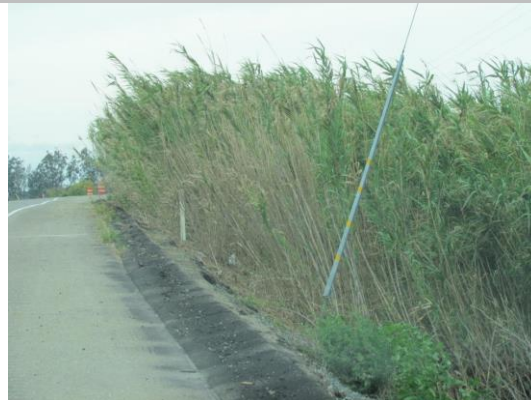
Photo 1 of 1 : SP_2018_RD0341_168_49_20180305_00015.jpg

LM Start	6.03	Rating **	U	Issue No.	49
LM End	6.10	Issue Type +	Ma	Location *	LS
Category	Earthen Levee			GPS Latitude/Longitude	
				Start	End
Item	Vegetation			38.080143 °	38.080125 °
				-121.728332 °	-121.729662 °
DWR ID	DWR_RD0341_02_f_2016_49				
Comment Code					
V2 : Remove the wild growth other than native grasses from the levee slopes.					
Inspector Comment					
Remove the bamboo from the landside levee slope.

RD 341 Landside slope from levee mile 6.03-6.10 tall unwanted growth of Arundo present on the levee section.

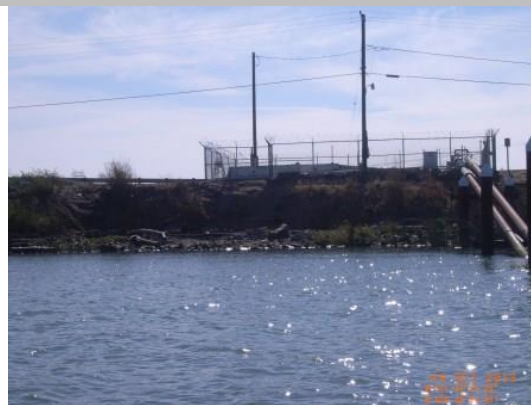
Photo 1 of 1 : SP_2018_RD0341_168_1_20180305_00001.jpg

LM Start	6.03	Rating **	U	Issue No.	1
LM End	6.16	Issue Type +	Ma	Location *	WS
Category	Supplemental			GPS Latitude/Longitude	
				Start	End
Item	2015 USACE Erosion Survey, DRAFT			38.080370 °	38.080526 °
				-121.728341 °	-121.730483 °
DWR ID	DWR_RD0341_02_s_2016_1				
Comment Code					
Inspector Comment					
2011 - Large slump at downstream end. Gully formed from surface runoff from the road. Shallow slumping throughout site. 2012 - The gully at upstream end has increased in size and site continues to worsen. 2015: No observed changes. [2015 Site ID: SAC_7-3_L]
